ON SCENE COORDINATOR COURSE

CASE STUDY : M/S LE JOOLA

By Capt Malick NDIAYE

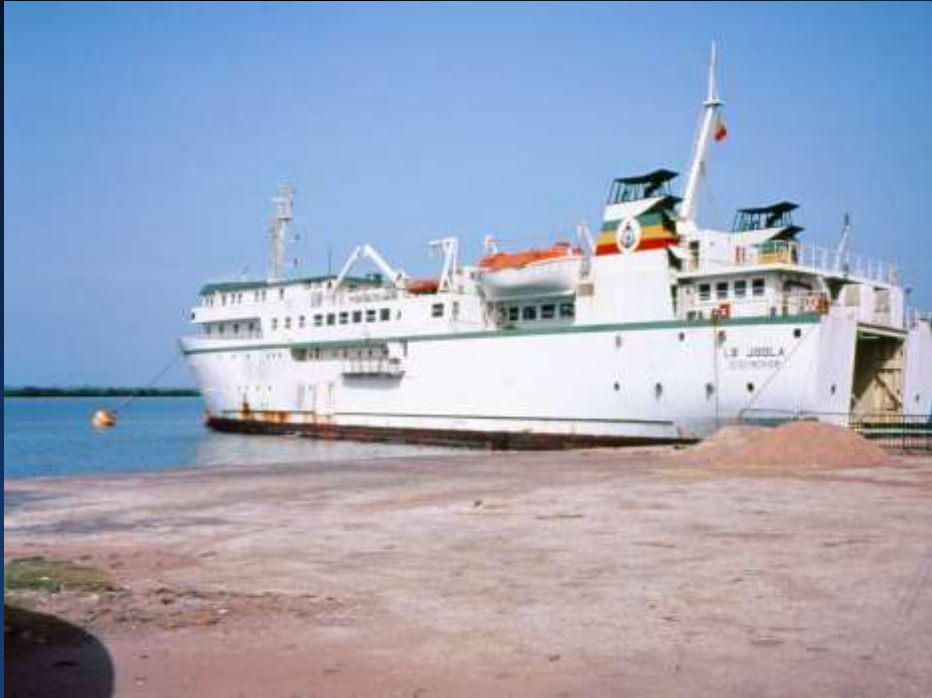
I-M/S LE JOOLA: General Characteristics

Class and type:	<u>Roll-on/roll-off</u> ferry
Tonnage:	2,087 <u>GRT</u>
Length:	79.5 m (260 ft 10 in)
Beam:	12 m (39 ft 4 in)
Draft:	3.1 m (10 ft 2 in)
Capacity:	•536 passengers •35 cars
Crew:	44

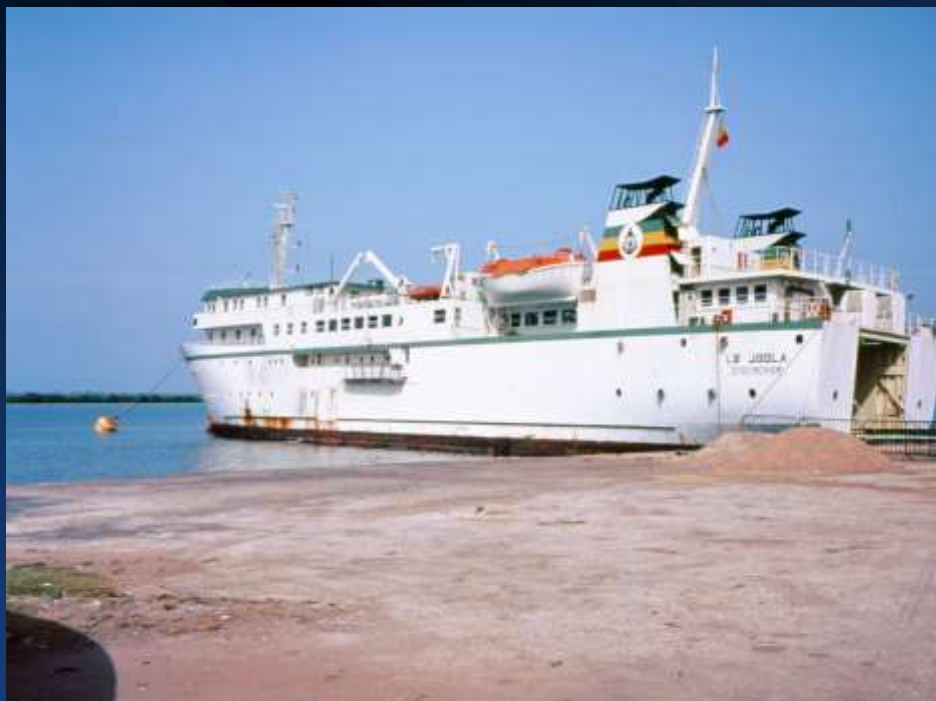
Name:	<i>Le Joola</i>
Owner:	Republique Senegal, Ministere de l'Equipement, Dakar / Senegal
Operator:	SenegaleseNavy
Port of registry:	<u>Senegal</u>
Route:	<u>Dakar to Casamance</u>
Builder:	Schiffswerft Germersheim GmbH (Germany)
Acquired:	1990
Out of service:	<ul style="list-style-type: none">•13 September 2001 – 10 September 2002•Mechanical damage repair and replacement of the port side engine
Identification:	<ul style="list-style-type: none">•<u>IMO number: 9019901</u>•<u>Callsign: 6VYZ</u>
Fate:	Capsized and sunk in rough seas 26 September 2002
Status:	Wreck
Notes:	The ship was overloaded with an estimated 1,863 aboard at the time of disaster.

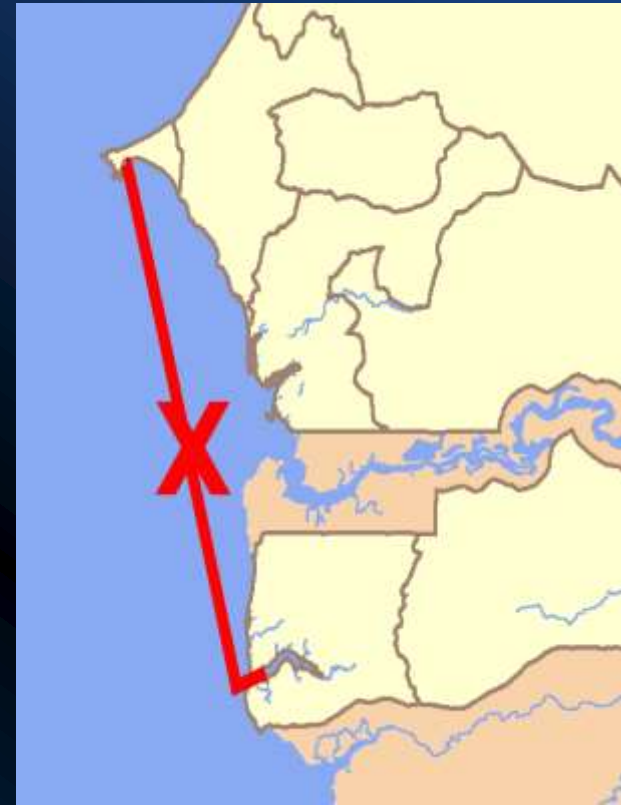
- At about 1:30 pm on : *Le Joola* set sail from Ziguinchor in the Casamance region;
- At 10 pm: last call from the ferry staff was broadcast to a maritime security center (navy operation coordination center) in Dakar. Reported good travel conditions;
- At around 11 pm, the ship sailed into a storm off the coast of Gambia;
- the ferry capsized, throwing passengers and cargo into the sea, all within five minutes

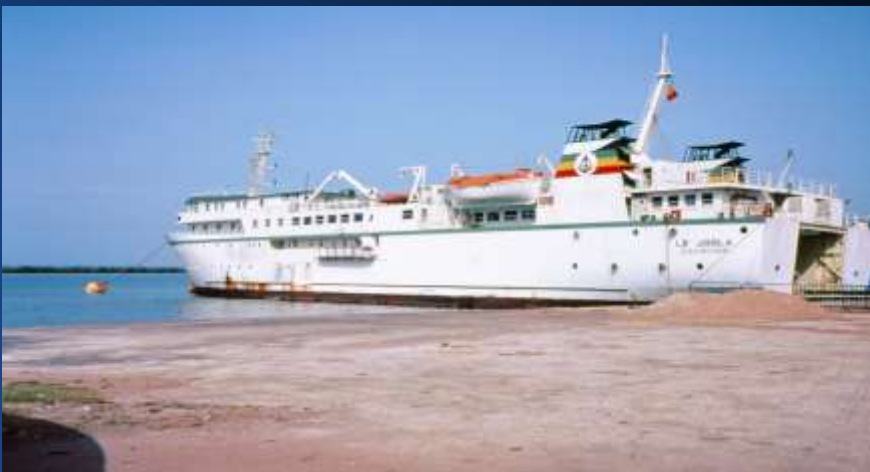
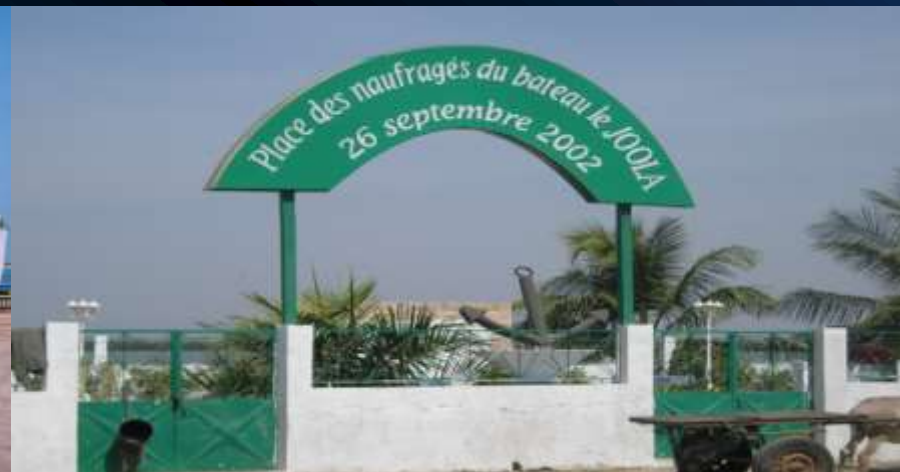
- Overcrowding: Ship was designed to carry a maximum of 580 passengers and crew, an estimated 2000 passengers are believed to have been on board and at least 1,863 died; 64 survivors.
- Failure to respond quickly enough to disaster; communications
- Slow rescue work; No OSC
- Poor coordination: Lack of SAR COORDINATOR, SMC

No alert system: Only predefined periods of communication with navy operational center;

No SAR system; contingency plan

NO OSC: A large number of fishing vessels around the hull waiting for instructions. Only 64 men overboard were rescued. Vessel capsized down.
